Barracuda Web Application Firewall Hardware Features

System hardware features include front and back panel controls, ports and LED indicators on the Barracuda Web Application Firewall.

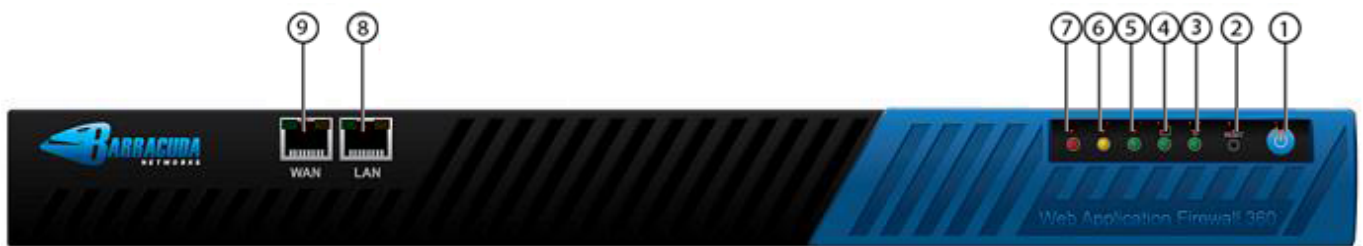
Table 1

Front Panel Features of Model 360 / 460

The following figure shows the front panel components of Model 360 and 460 described in [Table 1](#).

Diagram Location	Description
1	On/Off button
2	Reset button
3	Power Indicator
4	Disk Activity
5	Management Network Activity
6	Indicates System Bypass Mode
7	Indicates a Failed Status of the System
8	LAN Port
9	WAN Port

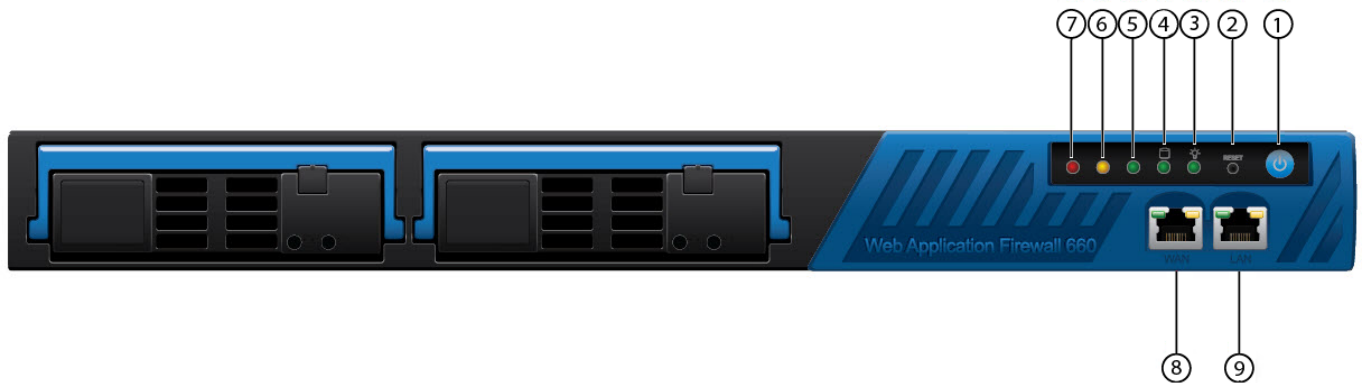
Table 5

Front Panel Features of Model 660

The following figure shows the front panel components described in [Table 5](#).

Diagram Location	Description
1	On/Off button
2	Reset button
3	Power Indicator
4	Disk Activity
5	Unused LED
6	Indicates System Bypass Mode
7	Indicates a Failed Status of the System
8	WAN Port
9	LAN Port
